Fire Risk Assessment

Property assessed: 1-124 Mossbrook Court Kentford Drive Manchester M40 7RE

Client: Northwards Housing

FRA Inspection Date: 14/11/2018
FRA Issued to Client: 30/11/2018
FRA valid to: 30/11/2019
FRA completed by: Savills (UK) Ltd,
33 Margaret Street, London W1G 0JD
T: 020 7409 8737
E: fireriskhousing@savills.com

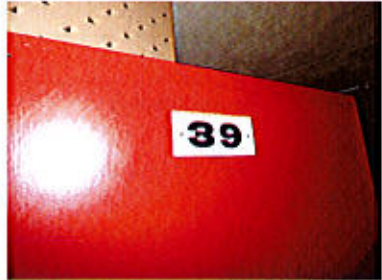
- Known	1		
- Potential	N/A		
Priority	A	Due Date: 31/03/2020	Client Status: Assigned
Question	L.6	<p>Comment: The self-closing device fitted to sampled flat 39 had been disabled/disconnected. No access to other flats.</p> <p>Recommendation: An effective self-closing device should be fitted to the door(s) as noted.</p>

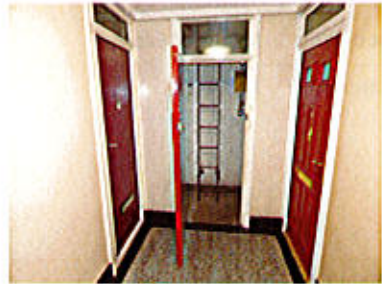
- Known	1		
- Potential	N/A		
Priority	A	Due Date: 31/03/2020	Client Status: Assigned
Question	M.1	<p>Comment: All common area fire doors and/or frames appear to be appropriately fire rated, except for the access door to the roof and lift motor room which was eggbox standard and not fire-resisting (N.B. - From limited visual inspection; certification not seen; adequacy of installation not confirmed). Note K.1 and ground floor screen and door to flat and lift lobby.</p> <p>Recommendation: Common area fire door(s) as noted should be replaced with self-closing FD30S fire doors, including appropriate 'Fire door keep shut' signage to both sides.</p>

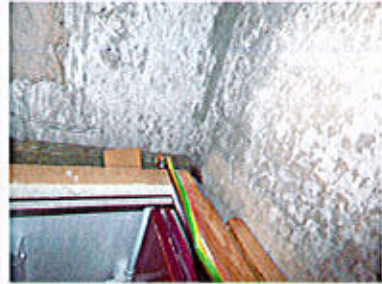
- Known	1		
- Potential	N/A		
Priority	A	Due Date: 31/03/2020	Client Status: Assigned
Question	Q.3	<p>Comment: The services gas riser cupboards sampled did not appear to be adequately fire resisting and/or fire-stopped. The gas intake on the ground floor was not fully fire-stopped from frame to the wall, there were examples where this was sealed correctly on 3rd & 8th floors.</p> <p>Recommendation: The services riser/cupboard construction should be replaced or upgraded to achieve 60 minutes fire resistance.</p>

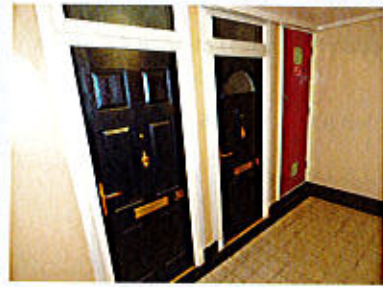
Question	Q.15	<p>Comment: Compartmentation would not appear to be adequate. There are intumescent ventilation grills present from the gas risers x4 each floor into the common stair. These will not prevent cold smoke entering the protected lobby to flats.</p>

Section	Limiting Fire Spread		
Action ID	114701		
Quantity		<p>Recommendation: The ventilation grills noted should be sealed up with fire resisting construction - period of fire resistance required is 30-minutes.</p>

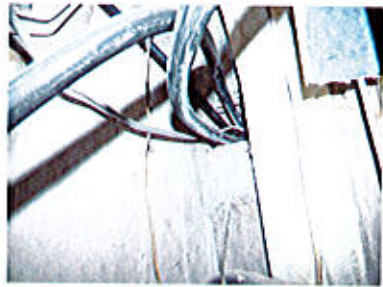
- Known	26		
- Potential	N/A		
Priority	B	Due Date: 27/12/2020	Client Status: Assigned
Question	Q.16	<p>Comment: Other fire spread/compartimentation issues noted at the time of inspection include - there is a breach in the main service riser on the ground floor in the side wall.</p>

Section	Limiting Fire Spread		
Action ID	114704		
Quantity		<p>Recommendation: The breach noted should be sealed up with fire resisting construction - period of fire resistance required is 60-minute fire resistance.</p>

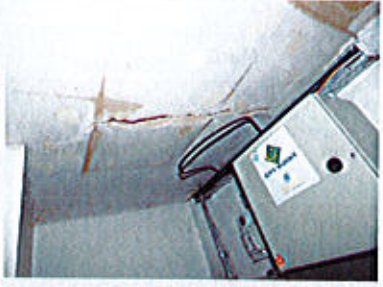
- Known	1		
- Potential	N/A		
Priority	B	Due Date: 27/12/2020	Client Status: Assigned
Question	Q.17	<p>Comment: Other fire spread/compartimentation issues noted at the time of inspection include - There is a breach to the ceiling to the room containing IT equipment in the cleaners store.</p>

Section	Limiting Fire Spread		
Action ID	114706		
Quantity		<p>Recommendation: Recommend the breach noted is fire stopped with 60minute fire rated material.</p>

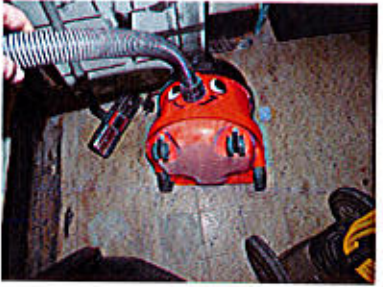
- Known	1		
- Potential	N/A		
Priority	B	Due Date: 27/12/2020	Client Status: Assigned
Question	A.4	<p>Comment: Portable Appliance Testing was confirmed as taking place every 2 years by the caretaker however a number of items would appear to have been missed.</p>

Section	Electrical Ignition Sources		
Action ID	113894		
Quantity		<p>Recommendation: Management should confirm/ensure that all portable electrical appliances in common areas are inspected and tested annually and records kept on-site or in a central database.</p>

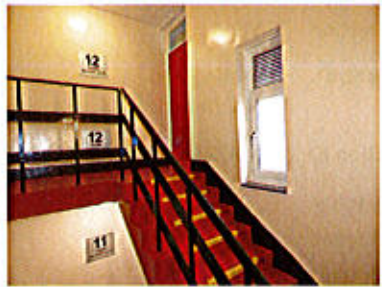
- Known	1			
- Potential	N/A			
Priority	C	Due Date: 04/06/2021	Client Status: Assigned	
Question	K.14	Comment: The vent to the head of the stairs appears to have been replaced with a window and small permanent vent 36cm x 38cm. All other floors have vents on the stair landing have also been replaced with a similar size vent and window. As a compensatory measure for not having a 1m2 PV to the head of the stair, adaptations to the openings on the top 2 floors are recommended. The vents to the stair lobby on all levels appear to have been 3 x vents 100cm x 50cm with the middle vent appearing to have been replaced by a glazed vision panel. Due to the small size of the lobby and the addition of additional fire resisting lobby door and screen to the flat lobby, this is not considered significant.

Section	Means of Escape			
Action ID	114080			
Quantity		Recommendation: The manually openable windows and vents to landings on the 11th and 12th floors should be replaced with suitable permanent vents.

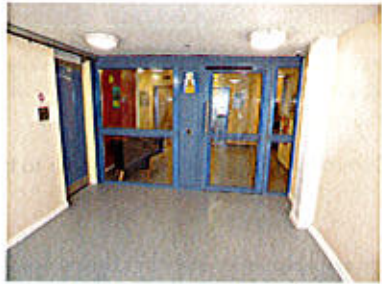
Question - K.1: Is the escape route design deemed satisfactory? (Consider current design codes)		No
<p>Comment: The means of escape design is not considered satisfactory. Upper flats discharge into a communal entrance lobby leading to a lobby protected stair on all floors 1st to 12th. Ground floor flats discharge into inner lobby leading to the stair lobby with ancillary rooms discharge into flat entrance lobby. The inner lobby door does not appear fire rated and has perspex glazing, therefore, the route does not have lobby protection at ground floor level.</p>		
<p>Recommendation: It is recommended that the lobby protection to the staircase be upgraded at ground floor level with FD30s and screen between the lift lobby and the outer stair lobby.</p>

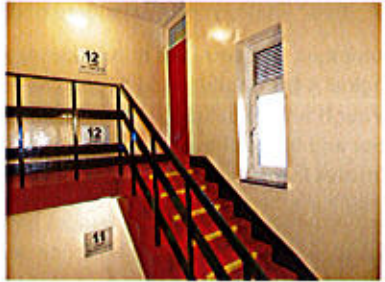
<p>Question - K.14: Are the stairs and/or lobbies provided with adequate permanent or manually operated ventilation openings for control of smoke? (State provision)</p>				No
<p>Comment: The vent to the head of the stairs appears to have been replaced with a window and small permanent vent 36cm x 38cm. All other floors have vents on the stair landing have also been replaced with a similar size vent and window. As a compensatory measure for not having a 1m² PV to the head of the stair, adaptations to the openings on the top 2 floors are recommended. The vents to the stair lobby on all levels appear to have been 3 x vents 100cm x 50cm with the middle vent appearing to have been replaced by a glazed vision panel. Due to the small size of the lobby and the addition of additional fire resisting lobby door and screen to the flat lobby, this is not considered significant.</p>				
<p>Recommendation: The manually openable windows and vents to landings on the 11th and 12th floors should be replaced with suitable permanent vents.</p>

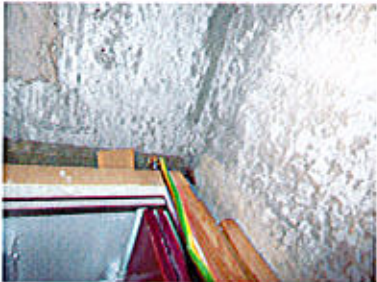
Question - Q.3: Are services risers, shafts, ducts and cupboards in the common area appropriately enclosed with fire resisting construction and adequately fire-stopped?				No
<p>Comment: The services gas riser cupboards sampled did not appear to be adequately fire resisting and/or fire-stopped. The gas intake on the ground floor was not fully fire-stopped from frame to the wall, there were examples where this was sealed correctly on 3rd & 8th floors.</p>				
<p>Recommendation: It is recommended that all gas service riser cupboards are inspected to ensure all are fire stopped to 60 minutes.</p>				
Priority: Man2	Known Quantity: 0	Potential Quantity: 26	Action ID: 114568

<p>Recommendation: The services riser/cupboard construction should be replaced or upgraded to achieve 60 minutes fire resistance.</p>				
Priority: B	Known Quantity: 1	Potential Quantity: N/A	Action ID: 114569

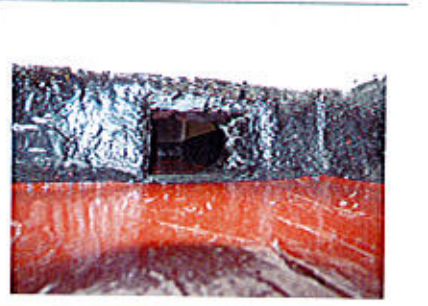
Question - Q.15: Are all other fire spread/compartmentation issues satisfactory? [2]			No
Comment: Compartmentation would not appear to be adequate. There are intumescent ventilation grills present from the gas risers x4 each floor into the common stair. These will not prevent cold smoke entering the protected lobby to flats.			
Recommendation: The ventilation grills noted should be sealed up with fire resisting construction - period of fire resistance required is 30-minutes.			
Priority: B	Known Quantity: 26	Potential Quantity: N/A	Action ID: 114701

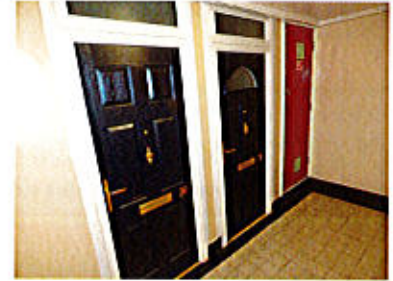
Question - Q.16: Are all other fire spread/compartmentation issues satisfactory? [3]			No
Comment: Other fire spread/compartmentation issues noted at the time of inspection include - there is a breach in the main service riser on the ground floor in the side wall.			
Recommendation: The breach noted should be sealed up with fire resisting construction - period of fire resistance required is 60-minute fire resistance.			
Priority: B	Known Quantity: 1	Potential Quantity: N/A	Action ID: 114704

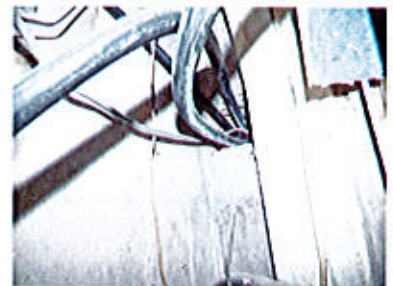
Question - Q.17: Are all other fire spread/compartmentation issues satisfactory? [4]			No
Comment: Other fire spread/compartmentation issues noted at the time of inspection include - There is a breach to the ceiling to the room containing IT equipment in the cleaners store.			
Recommendation: Recommend the breach noted is fire stopped with 60minute fire rated material.			
Priority: B	Known Quantity: 1	Potential Quantity: N/A	Action ID: 114706
