Fire Risk Assessment

Property assessed: 1-62 Roach Court 42 Hamerton Road Manchester M40 7QP

Client: Northwards Housing

FRA Inspection Date: 14/11/2018
FRA Issued to Client: 30/11/2018
FRA valid to: 30/11/2019
FRA completed by: Savills (UK) Ltd,
33 Margaret Street, London W1G 0JD
T: 020 7409 8737
E: fireriskhousing@savills.com

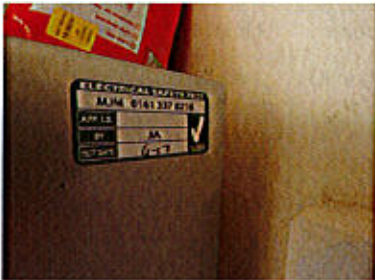
Question	A.4	<p>Comment: No evidence was available on site to confirm that all portable electrical appliances in use in the common areas are inspected and tested annually. There are some items dated 04/17 and others not labeled.</p>

Section	Electrical Ignition Sources		
Action ID	115056		
Quantity		<p>Recommendation: Management should confirm/ensure that all portable electrical appliances in common areas are inspected and tested annually and records kept on-site or in a central database.</p>

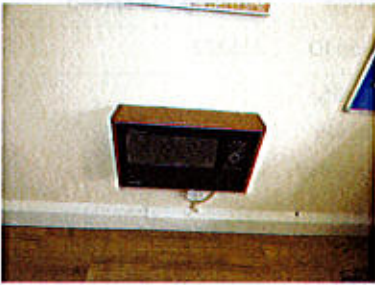
- Known	N/A		
- Potential	N/A		
Priority	Man2	Due Date: 27/12/2020	Client Status: Assigned
Question	D.2	<p>Comment: No evidence was available on-site to confirm regular inspection, testing and servicing of the system is being carried out.</p>

Section	Space Heating		
Action ID	115060		
Quantity		<p>Recommendation: Management should confirm/ensure that the fixed electrical heating appliances in the common area are tested as part of the fixed electrical system test regime and records kept on-site or in a central database.</p>

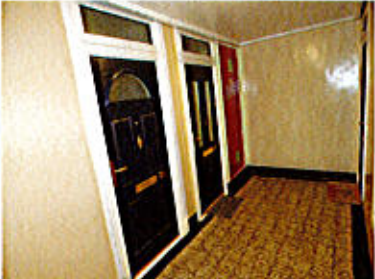
- Known	N/A		
- Potential	N/A		
Priority	Man2	Due Date: 27/12/2020	Client Status: Assigned
Question	L.1	<p>Comment: Flat entrance doors/frames are replacement composite fire doors, except for flat(s) 16, 34, 36 & 37 which are notional original 44mm solid wood doors. The composite doors from observation on site are a mix of Permadoor solid and glazed and consistent throughout the building. (N.B. - From limited visual inspection; certification not seen; adequacy of installation not confirmed). Flat entrance door and frames have been fitted into openings with architraves/cover-slips indicating the potential for voids behind the frame. Further intrusive inspection is needed to confirm the adequacy of the fixings and fire stopping behind.</p>

Section	Flat Entrance/Residents' Bedroom/Bedsit Doors		
Action ID	115175		
Quantity		<p>Recommendation: As flat entrances have been fitted with composite doorsets, MHCLG advise that these should have test evidence demonstrating they meet the performance requirement in Building Regulations guidance for fire resistance and smoke control from both sides. Management should confirm that suitable fire door test certificates are held and that these relate to the doors fitted. If adequacy cannot be confirmed it may be necessary for doorsets to be replaced under a risk-based programme.</p>

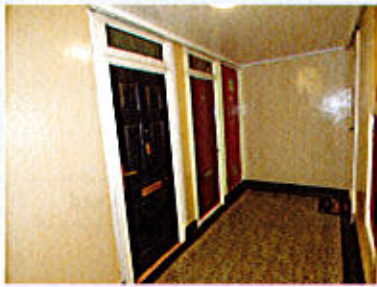
- Known	0		
- Potential	50		
Priority	Man2	Due Date: 27/12/2020	Client Status: Assigned
Question	L.6	<p>Comment: The self-closing device fitted to sampled flat 54 had been disabled/disconnected. Flats 31 & 54 have effective self-closing devices. No access to other flats.</p>

Section	Flat Entrance/Residents' Bedroom/Bedsit Doors		
Action ID	115186		
Quantity		<p>Recommendation: Flat entrance doors not sampled at the time of this inspection should be checked as part of a rolling programme to confirm that self-closers are fitted and remain effective.</p>

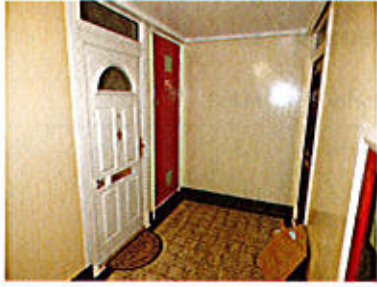
- Known	0		
- Potential	50		
Priority	Man2	Due Date: 27/12/2020	Client Status: Assigned
Question	L.7	<p>Comment: Sampled flat 31, 54 & 61 entrance door was fitted with intumescent strips and cold smoke seals. No access to other flats.</p>

Section	Flat Entrance/Residents' Bedroom/Bedsit Doors		
Action ID	115188		
Quantity		<p>Recommendation: Flat entrance doors not sampled at the time of this inspection should be checked as part of a rolling programme to confirm that strips and seals are fitted and remain effective.</p>

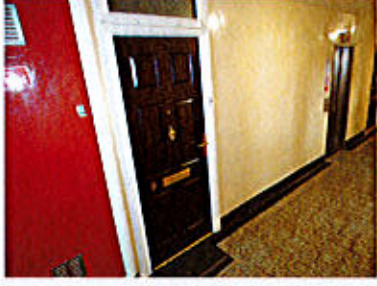
- Known	0		
- Potential	50		
Priority	Man2	Due Date: 27/12/2020	Client Status: Assigned
Question	P.5	<p>Comment: There was no smoke alarm seen in the entrance hallway of sample flat 31. No access to other flats with exception of 54 & 61 which had Grade D smoke alarms.</p>

Section	Means of Giving Warning in Case of Fire		
Action ID	115268		
Quantity		<p>Recommendation: Flats not sampled at the time of this inspection should be checked to confirm provision and working condition of at least Grade D LD3 smoke alarm systems to BS5839-6:2014.</p>

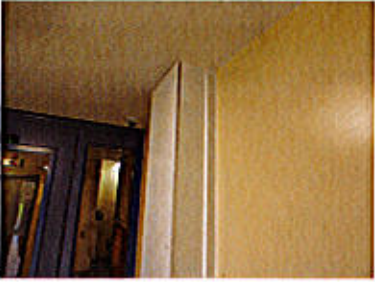
Question	Q.2	<p>Comment: It was not possible to sample inspect the hidden void(s) identified without causing damage or requiring opening up. There was boxing in the outer ground lobby and cover panels in each lobby under external windows from 1st to 12th floors with unknown services.</p>

Section	Limiting Fire Spread		
Action ID	115277		
Quantity		<p>Recommendation: A sample check should be made of the boxed-in services ductwork to confirm that the construction is adequately fire resisting and that compartmentation behind has not been compromised at services penetrations etc.</p>

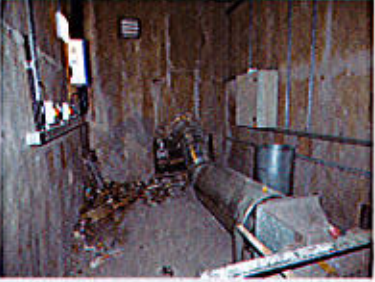
- Known	0		
- Potential	13		
Priority	Man2	Due Date: 27/12/2020	Client Status: Assigned
Question	Q.9	<p>Comment: It is presumed there is a common ventilation system that runs the height of the building with an extraction system located on the roof. The configuration is unknown.</p>

Section	Limiting Fire Spread		
Action ID	115284		
Quantity		<p>Recommendation: Recommend further investigation is undertaken by a specialist to confirm location and condition of the common ventilation system.</p>

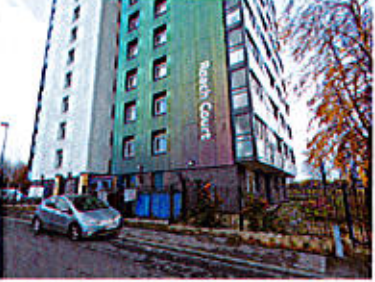
- Known	0		
- Potential	1		
Priority	Man2	Due Date: 27/12/2020	Client Status: Assigned
Question	Q.13	<p>Comment: No information was available on site to confirm if the external wall rain screen cladding/insulation system met the requirements of the Building Regulations with regards to limited combustibility and surface fire spread requirements.</p>

Section	Limiting Fire Spread		
Action ID	115286		
Quantity		<p>Recommendation: Management should confirm that the external wall rain screen cladding/insulation system meets Building Regulations requirements with regards to limited combustibility and surface fire spread properties.</p>

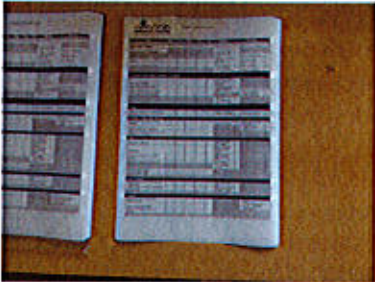
- Known	N/A			
- Potential	N/A			
Priority	Man2	Due Date: 27/12/2020	Client Status: Assigned	
Question	T.11	Comment: From information received on-site, it would appear that routine in-house fire safety checks are not being carried out at present as there has been a change of staff and the daily checks are not being implemented OR not recorded only blank forms could be located.

Section	Procedures and Arrangements			
Action ID	115691			
Quantity		Recommendation: Management should confirm/ensure that routine in-house fire safety checks are carried out on a regular basis (daily or weekly depending on building usage) and records kept on-site or in a central database.

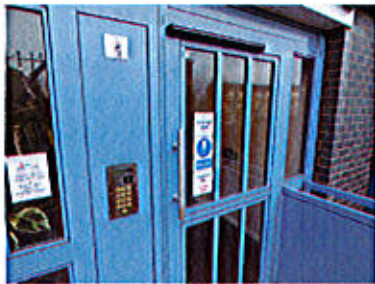
- Known	N/A			
- Potential	N/A			
Priority	Man2	Due Date: 27/12/2020	Client Status: Assigned	
Question	V.9	Comment: No evidence was available on-site to confirm regular inspection, testing and servicing of the system is being carried out.

Section	Testing and Maintenance			
Action ID	115300			
Quantity		Recommendation: Management should confirm/ensure that the drop key override switch facilities for Fire and Rescue Service access are inspected, tested and serviced in accordance with relevant guidance and records kept on-site or in a central database.

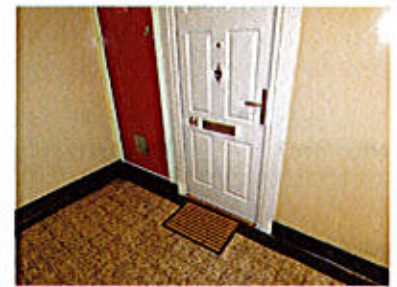
Details		Comments/recommendations	Photo
Question	G.4	<p>Comment: There were trip hazards noted within the common escape routes at the time of inspection. There were plants in outer lobby, seats in the ground floor lift lobby and unsuitable doormats on several floors.</p> <p>Recommendation: Trip hazards noted should be removed from the common area and the area kept clear.</p>	
Section	House-Keeping		
Action ID	115062		
Quantity

Question - G.4: Are escape routes kept clear of any trip hazards?

Recommendation: Trip hazards noted should be removed from the common area and the area kept clear.

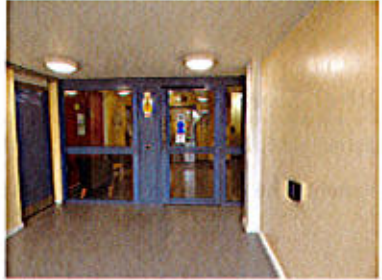
Question - K.1: Is the escape route design deemed satisfactory? (Consider current design codes)			No
<p>Comment: The means of escape design is not considered satisfactory. Upper flats discharge into a communal entrance lobby leading to a lobby protected stair on all floors 1st to 12th. Ground floor flats discharge into inner lobby leading to the stair lobby with ancillary rooms discharge into flat entrance lobby. The inner lobby door does not appear fire rated and has perspex glazing, therefore, the route does not have lobby protection at ground floor level.</p>			
<p>Recommendation: It is recommended that the lobby protection to the staircase be upgraded at ground floor level with FD30s and screen between the lift lobby and the outer stair lobby.</p>

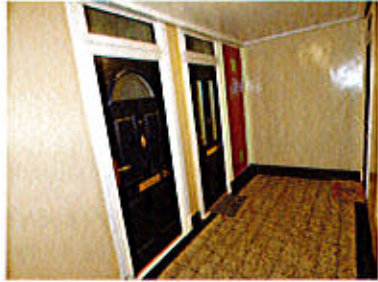
<p>Question - L.1: Are all flat entrance (or residents' bedroom/bedsit) doors and frames appropriately fire rated? (State type and standard of doors)</p>				No
<p>Comment: Flat entrance doors/frames are replacement composite fire doors, except for flat(s) 16, 34, 36 & 37 which are notional original 44mm solid wood doors. The composite doors from observation on site are a mix of Permadoor solid and glazed and consistent throughout the building. (N.B. - From limited visual inspection; certification not seen; adequacy of installation not confirmed). Flat entrance door and frames have been fitted into openings with architraves/cover-slips indicating the potential for voids behind the frame. Further intrusive inspection is needed to confirm the adequacy of the fixings and fire stopping behind.</p>				
<p>Recommendation: As flat entrances have been fitted with composite doorsets, MHCLG advise that these should have test evidence demonstrating they meet the performance requirement in Building Regulations guidance for fire resistance and smoke control from both sides. Management should confirm that suitable fire door test certificates are held and that these relate to the doors fitted. If adequacy cannot be confirmed it may be necessary for doorsets to be replaced under a risk-based programme.</p>

Priority: Man2	Known Quantity: 0	Potential Quantity: 50	Action ID: 115175	
<p>Recommendation: As flat entrances have been fitted with composite doorsets, an intrusive inspection should be carried out to confirm the adequacy of the fixings and firestopping between the frame and the wall.</p>				
Priority: Man2	Known Quantity: 0	Potential Quantity: 50	Action ID: 117903	No image available
<p>Question - L.2: Are fire rated flat entrance (or residents' bedroom/bedsit) doors and frames in good condition - not in need of repair?</p>				Yes
<p>Comment: The fire rated flat entrance doors appear to be in good condition, however, note L.1 & L.9.</p>				
<p>Question - L.3: Is all glazing to flat entrance (or residents' bedroom/bedsit) doors appropriately fire rated?</p>				Yes
<p>Comment: The glazing to flat entrance doors appears to be appropriately fire rated, however, note L.1 & L.9.</p>				
<p>Question - L.4: Are fanlights above flat entrance (or residents' bedroom/bedsit) doors appropriately fire rated?</p>				Not Known

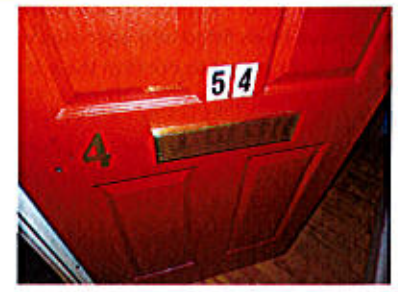
Section	Means of Escape		
Action ID	117896		
Quantity			
- Known	1		
- Potential	1		
Priority	A	Due Date: 31/03/2020	Client Status: Assigned
Question	L.6	<p>Comment: The self-closing device fitted to sampled flat 54 had been disabled/disconnected. Flats 31 & 54 have effective self-closing devices. No access to other flats.</p> <p>Recommendation: An effective self-closing device should be fitted to the door(s) as noted.</p>	
Section	Flat Entrance/Residents' Bedroom/Bedsit Doors		
Action ID	115185		
Quantity

Recommendation: An effective self-closing device should be fitted to the door(s) as noted.

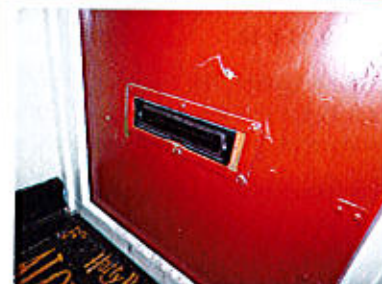
Question	L.8	Comment: Letterboxes fitted to flat 37 entrance door(s) are defective. The outer flap to the letterbox to a notional FD30 door is missing.	
Section	Flat Entrance/Residents' Bedroom/Bedsit Doors		
Action ID	115192		
Quantity		Recommendation: Letterboxes to flat entrance doors as noted should be replaced with fire rated letterboxes.

Recommendation: Letterboxes to flat entrance doors as noted should be replaced with fire rated letterboxes.

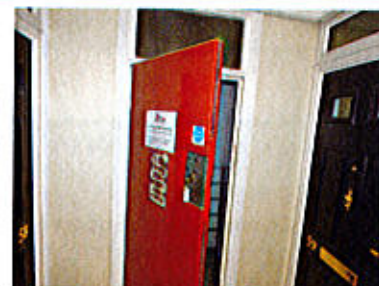
- Known	1		
- Potential	N/A		
Priority	A	Due Date: 31/03/2020	Client Status: Assigned
Question	M.1	Comment: All common area fire doors and/or frames appear to be appropriately fire rated, except for for the access door to the roof and lift motor room which was eggbox standard and not fire-resisting. (N.B. - From limited visual inspection; certification not seen; adequacy of installation not confirmed).	
Section	Common Area Fire Doors		
Action ID	115214		
Quantity		Recommendation: Common area fire door(s) as noted should be replaced with lockable FD30S fire doors, including appropriate 'Fire door keep locked' signage to the outer face.

Recommendation: Common area fire door(s) as noted should be replaced with lockable FD30S fire doors, including appropriate 'Fire door keep locked' signage to the outer face.

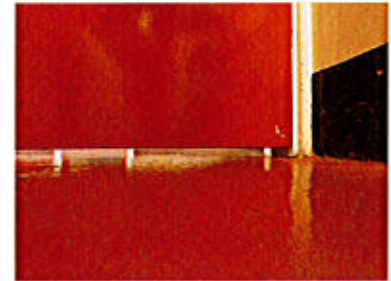
- Known	1		
- Potential	N/A		
Priority	C	Due Date: 04/06/2021	Client Status: Assigned
Question	M.2	Comment: All common area fire rated fire doors appear to be in good condition except for several doors with excessive gaps between the door and the threshold. Doors with excessive gaps include FD30s to lift lobby 1, 2, 3, 6, 7 & 8 AND to refuse chute rooms 3 & 4 AND to stairs 2, 3, 8, 9, 10, 11 & 12.	
Section	Common Area Fire Doors		
Action ID	115224		
Quantity		Recommendation: The common area doors noted should be repaired (or if necessary replaced) to reduce the threshold gap to a maximum of 6mm. Alternatively, a threshold seal capable of resisting cold smoke should be fitted.

Recommendation: The common area doors noted should be repaired (or if necessary replaced) to reduce the threshold gap to a maximum of 6mm. Alternatively, a threshold seal capable of resisting cold smoke should be fitted.

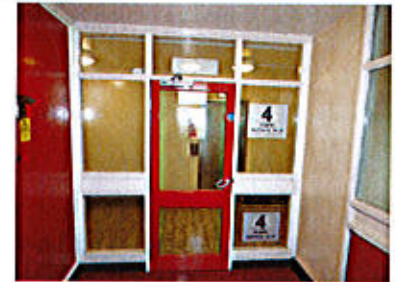
- Known	1		
- Potential	N/A		
Priority	A	Due Date: 31/03/2020	Client Status: Assigned
Question	M.7	Comment: Other common area fire door issues noted at the time of inspection include - The lift lobby door 4th floor has dropped on its hinge.	
Section	Common Area Fire Doors		
Action ID	115240		
Quantity		Recommendation: Minor joinery repairs are required to the door(s)/frame(s) noted - to ensure the FD30s works effectively.

Recommendation: Minor joinery repairs are required to the door(s)/frame(s) noted - to ensure the FD30s works effectively.

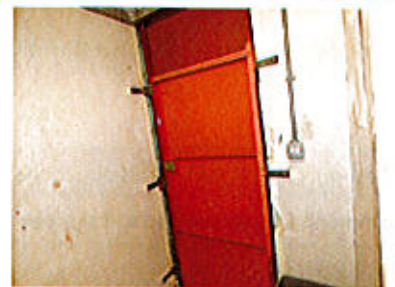
- Known	1		
- Potential	N/A		
Priority	A	Due Date: 31/03/2020	Client Status: Assigned
Question	M.8	Comment: Other common area fire door issues noted at the time of inspection include - Internal doors within the caretaker's store area were not all fire rated doors there is steel door from this area to lift lobby which will provide an unknown level of fire-resistance and the installation would appear to have gaps around the frame.	
Section	Common Area Fire Doors		
Action ID	115251		
Quantity		Recommendation: The common area fire door(s) as noted should be replaced with an FD30S lockable fire door.

Recommendation: The common area fire door(s) as noted should be replaced with an FD30S lockable fire door.

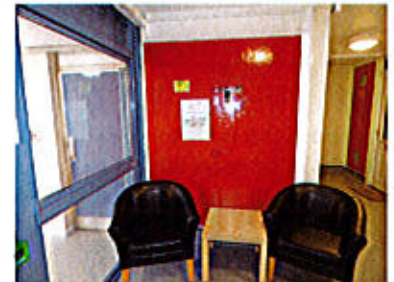
- Known	15		
- Potential	N/A		
Priority	C	Due Date: 04/06/2021	Client Status: Assigned
Question	O.2	Comment: Fire door signage is not considered adequate. The service cupboards in the stair lobby & gas risers had no "Fire Door Keep Locked" signs fitted.	
Section	Fire Safety Signs and Notices		
Action ID	115262		
Quantity		Recommendation: Provide 'Fire door keep locked' signage to the electrical cupboard fire door(s)

Recommendation: Provide 'Fire door keep locked' signage to the electrical cupboard fire door(s)

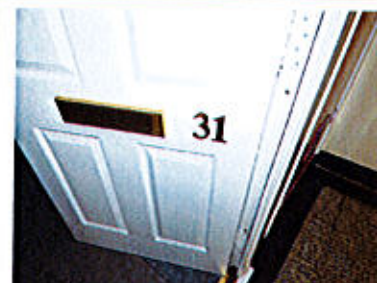
- Known	40		
- Potential	N/A		
Priority	C	Due Date: 04/06/2021	Client Status: Assigned
Question	P.5	Comment: There was no smoke alarm seen in the entrance hallway of sample flat 31. No access to other flats with exception of 54 & 61 which had Grade D smoke alarms.	
Section	Means of Giving Warning in Case of Fire		
Action ID	115267		
Quantity		Recommendation: A Grade D LD3 smoke alarm system to BS5839-6:2013 should be installed in the flats noted.

Recommendation: A Grade D LD3 smoke alarm system to BS5839-6:2013 should be installed in the flats noted.

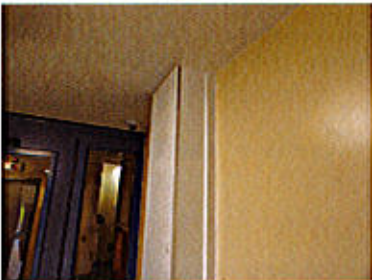
<p>Question - Q.2: Are any hidden voids identified during the inspection appropriately enclosed and/or fire-stopped? (consider above suspended ceilings and behind casings)</p>				Not Known
<p>Comment: It was not possible to sample inspect the hidden void(s) identified without causing damage or requiring opening up. There was boxing in the outer ground lobby and cover panels in each lobby under external windows from 1st to 12th floors with unknown services.</p>				
<p>Recommendation: A sample check should be made of the boxed-in services ductwork to confirm that the construction is adequately fire resisting and that compartmentation behind has not been compromised at services penetrations etc.</p>

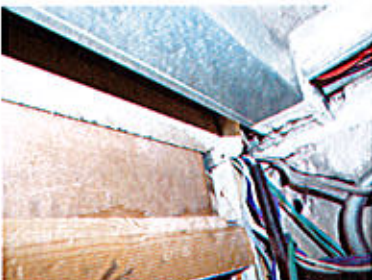
<p>Question - Q.3: Are services risers, shafts, ducts and cupboards in the common area appropriately enclosed with fire resisting construction and adequately fire-stopped?</p>				No
<p>Comment: The services riser/cupboards sampled did not appear to be adequately fire resisting and/or fire-stopped. The riser in the ground floor lift lobby was not fully enclosed.</p>				
<p>Recommendation: The services riser/cupboard construction should be replaced or upgraded to achieve 60 minutes fire resistance.</p>

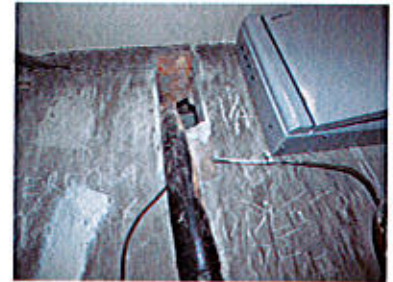
Question - Q.7: Are electrical installations/intakes enclosed in fire rated construction? (Where necessary)				No
Comment: The electrical intake/meter enclosure did not appear to be adequately fire-resisting.				
Recommendation: The hole/s noted should be sealed with a suitable fire-stopping material such as an intumescent paste. Period of fire resistance required is 60 minutes.				
Priority: B	Known Quantity: 1	Potential Quantity: N/A	Action ID: 115282

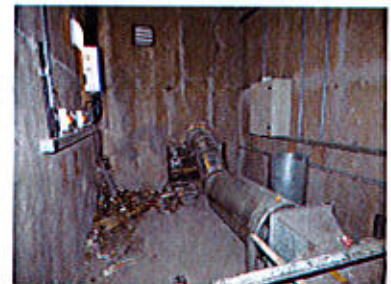
Question - Q.9: If present, are common ventilation systems, ventilation ducts and grills adequate to limit fire spread/growth? (Consider dampers etc.)				Not Known
Comment: It is presumed there is a common ventilation system that runs the height of the building with an extraction system located on the roof. The configuration is unknown.				
Recommendation: Recommend further investigation is undertaken by a specialist to confirm location and condition of the common ventilation system.				
Priority: Man2	Known Quantity: 0	Potential Quantity: 1	Action ID: 115284

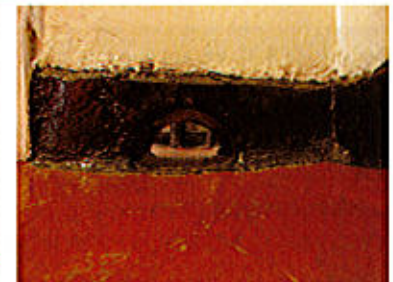
- Known	1		
- Potential	N/A		
Priority	B	Due Date: 27/12/2020	Client Status: Assigned
Question	Q.14	Comment: Other fire spread/compartmentation issues noted at the time of inspection include - There are low-level openings between the stair lobby and the refuse chute lobby on each floor.	 
Section	Limiting Fire Spread		
Action ID	115287		
Quantity		Recommendation: The holes noted should be sealed up with fire resisting construction - period of fire resistance required is 30-minutes.

Recommendation: The holes noted should be sealed up with fire resisting construction - period of fire resistance required is 30-minutes.

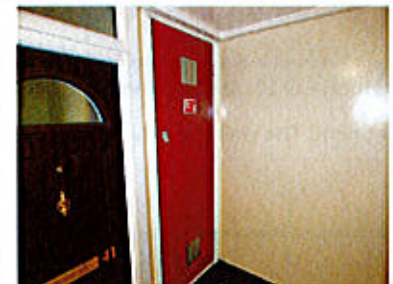
- Known	12		
- Potential	N/A		
Priority	B	Due Date: 27/12/2020	Client Status: Assigned
Question	Q.15	Comment: Compartmentation would not appear to be adequate. There are intumescent ventilation grills present from the gas risers x4 each floor into the common stair. These will not prevent cold smoke entering the protected lobby to flats.	 
Section	Limiting Fire Spread		
Action ID	115290		
Quantity		Recommendation: Previously Reported - The ventilation grills noted should be sealed up with fire resisting construction - period of fire resistance required is 30-minutes.

Recommendation: Previously Reported - The ventilation grills noted should be sealed up with fire resisting construction - period of fire resistance required is 30-minutes.
