Fire Risk Assessment

Property assessed: 1-124 Mossbrook Court Kentford Drive Manchester M40 7RE

Client: Northwards Housing

FRA Inspection Date: 14/11/2018
FRA Issued to Client: 30/11/2018
FRA valid to: 30/11/2019
FRA completed by: Savills (UK) Ltd,
33 Margaret Street, London W1G 0JD
T: 020 7409 8737
E: fireriskhousing@savills.com

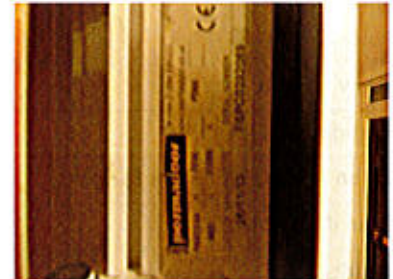
Question	L.1	<p>Comment: Flat entrance doors/frames are replacement composite fire doors, except for flat(s) 21, 24, 39, 52 58 & 61 which are notional original 44mm solid wood doors. The composite doors from observation on site are a mix of Permadoor solid and glazed units and consistent throughout the building. (N.B. - From limited visual inspection; certification not seen; adequacy of installation not confirmed). Flat entrance door and frames have been fitted into openings with architraves/cover-slips indicating the potential for voids behind the frame. Further intrusive inspection is needed to confirm the adequacy of the fixings and fire stopping behind.</p>
Section	Flat Entrance/Residents' Bedroom/Bedsit Doors	
Action ID	114116	
Quantity		<p>Recommendation: As flat entrances have been fitted with composite doorsets, MHCLG advise that these should have test evidence demonstrating they meet the performance requirement in Building Regulations guidance for fire resistance and smoke control from both sides. Management should confirm that suitable fire door test certificates are held and that these relate to the doors fitted. If adequacy cannot be confirmed it may be necessary for doorsets to be replaced under a risk-based programme.</p>

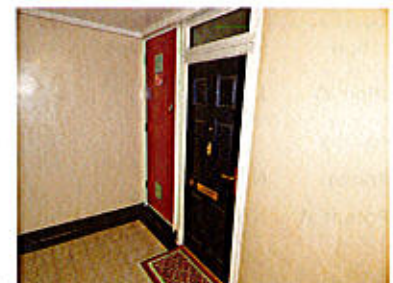
Priority	Man2	Due Date: 27/12/2020	Client Status: Assigned
Question	L.6	<p>Comment: The self-closing device fitted to sampled flat 39 had been disabled/disconnected. No access to other flats.</p>	
Section	Flat Entrance/Residents' Bedroom/Bedsit Doors		
Action ID	114172		
Quantity		<p>Recommendation: Flat entrance doors not sampled at the time of this inspection should be checked as part of a rolling programme to confirm that self-closers are fitted and remain effective.</p>	
- Known	0		
- Potential	58

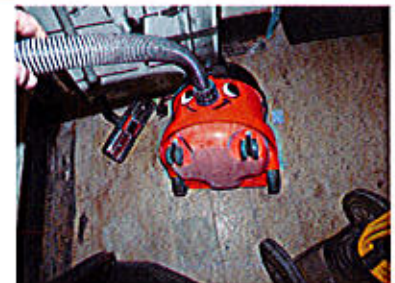
Question - A.4: Is portable appliance testing (PAT) being completed within the common areas?	No
Comment: Portable Appliance Testing was confirmed as taking place every 2 years by the caretaker however a number of items would appear to have been missed.

Recommendation: Management should confirm/ensure that all portable electrical appliances in common areas are inspected and tested annually and records kept on-site or in a central database.			
Priority: Man2	Known Quantity: N/A	Potential Quantity: N/A	Action ID: 113894

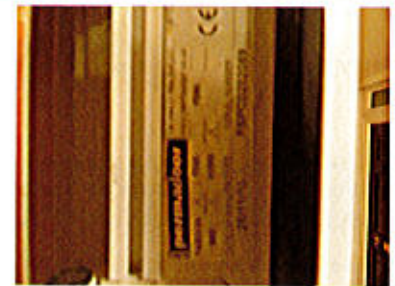
Comment: Flat entrance doors/frames are replacement composite fire doors, except for flat(s) 21, 24, 39, 52 58 & 61 which are notional original 44mm solid wood doors. The composite doors from observation on site are a mix of Permadoor solid and glazed units and consistent throughout the building. (N.B. - From limited visual inspection; certification not seen; adequacy of installation not confirmed). Flat entrance door and frames have been fitted into openings with architraves/cover-slips indicating the potential for voids behind the frame. Further intrusive inspection is needed to confirm the adequacy of the fixings and fire stopping behind.

Recommendation: As flat entrances have been fitted with composite doorsets, MHCLG advise that these should have test evidence demonstrating they meet the performance requirement in Building Regulations guidance for fire resistance and smoke control from both sides. Management should confirm that suitable fire door test certificates are held and that these relate to the doors fitted. If adequacy cannot be confirmed it may be necessary for doorsets to be replaced under a risk-based programme.

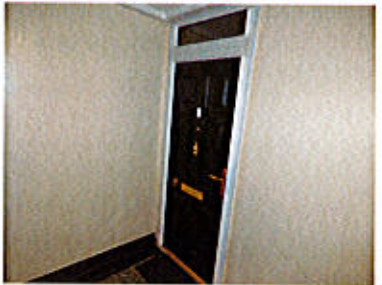
Question - L.7: Are all sampled flat entrance (or residents' bedroom/bedsit) doors fitted with intumescent strips and cold smoke seals and is there a rolling programme of fire door checks in place to include those not sampled?	Not Known
Comment: Sampled flat 39, 50, 26 & 5 entrance door was fitted with intumescent strips and cold smoke seals. No access to other flats.

Recommendation: Flat entrance doors not sampled at the time of this inspection should be checked as part of a rolling programme to confirm that strips and seals are fitted and remain effective.

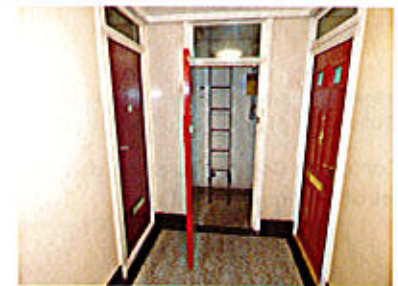
Comment: All common area fire doors and/or frames appear to be appropriately fire rated, except for the access door to the roof and lift motor room which was eggbox standard and not fire-resisting (N.B. - From limited visual inspection; certification not seen; adequacy of installation not confirmed). Note K.1 and ground floor screen and door to flat and lift lobby.

Recommendation: Common area fire door(s) as noted should be replaced with self-closing FD30S fire doors, including appropriate 'Fire door keep shut' signage to both sides.

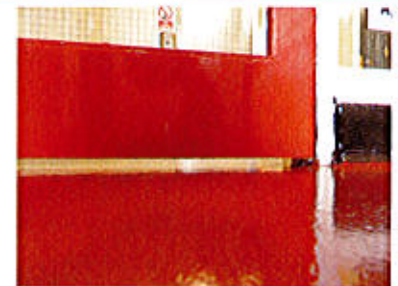
Comment: All common area fire rated fire doors appear to be in good condition except for several doors with excessive gaps between the door and the frame and the threshold. Doors with gaps to the frame include lift lobby 11th floor & 12th to refuse chute room. Doors with gaps at the threshold include 8, 9, 10, 11, & 12th door to stairs

Recommendation: The common area doors noted should be repaired (or if necessary replaced) to reduce the threshold gap to a maximum of 6mm. Alternatively, a threshold seal capable of resisting cold smoke should be fitted.

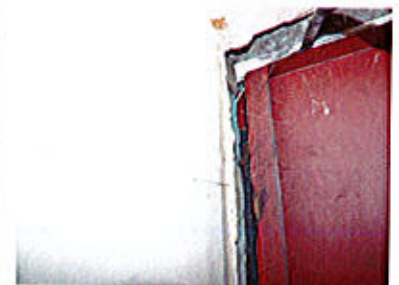
Comment: Other common area fire door issues noted at the time of inspection include - Internal doors within the caretaker's store area were not all fire rated doors there is steel door from this area to lift lobby and deemed satisfactory which will provide an appropriate level of fire rating, however, the installation would appear to have gaps around the frame and installation.

Recommendation: The common area door noted should be installed to ensure it provides FD30s provision (or if necessary replaced) to reduce potential gaps around the door and frame to the wall.

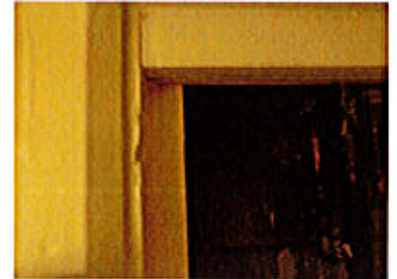
Question - M.8: Are all other common area fire door issues satisfactory?				No
Comment: The following common fire door issue(s) were noted at the time of inspection:- There was a variance of standard with regard to rebate and intumescent strip & cold smoke seal to gas riser FD30 doors. Example 8th floor rebate missing at the head and on 9th intumescent strip & cold smoke seal installed to the base of the door.				
Recommendation: It is recommended that all gas riser FD30 doors are inspected and provision of rebates with intumescent strips & cold smoke seals installed to the doors confirmed.				
Priority: Man2	Known Quantity: 0	Potential Quantity: 26	Action ID: 114770

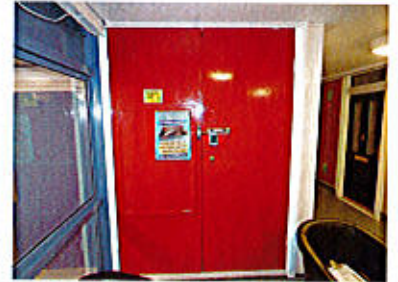
<p>Question - O.2: Is fire door signage adequate? (Consider 'Fire door keep shut', 'Fire door keep locked shut' and 'Automatic Fire Door Keep Clear' signage. Exclude doors recommended for replacement)</p>				No
<p>Comment: Fire door signage is not considered adequate. There are no 'Fire door keep locked' signage to the stair lobby service cupboard, gas riser, caretakers ancillary room and lift motor room fire doors</p>				
<p>Recommendation: Provide 'Fire door keep locked' and/or 'Fire door keep shut' notices to common area fire doors as noted.</p>				
Priority: C	Known Quantity: 39	Potential Quantity: N/A	Action ID: 114288

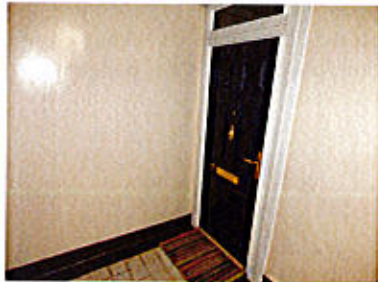
<p>Question - P.5: If applicable, are independent domestic hard-wired smoke/heat alarm systems within the sampled flats installed to a suitable standard and is there a rolling programme of checks in place to include those not sampled? (Grade D LD3 minimum standard)</p>				Yes
<p>Comment: A Grade D smoke alarm was noted within the entrance hallway of sample flat 39 and 5, 26 & 50. No access to other flats.</p>				
<p>Recommendation: Flats not sampled at the time of this inspection should be checked to confirm provision and working condition of at least Grade D LD3 smoke alarm systems to BS5839-6:2014.</p>

Priority: Man2	Known Quantity: 0	Potential Quantity: 58	Action ID: 114295

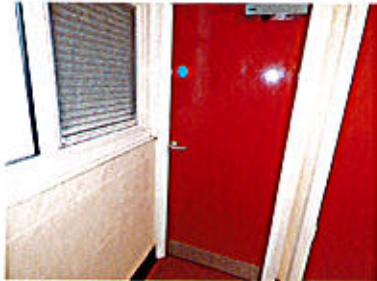
Question - Q.2: Are any hidden voids identified during the inspection appropriately enclosed and/or fire-stopped? (consider above suspended ceilings and behind casings)				Not Known
<p>Comment: It was not possible to sample inspect the hidden void(s) identified without causing damage or requiring opening up. There was boxing in the outer ground lobby and cover panels in each lobby under external windows from 1st to 12th floors with unknown services.</p>				
<p>Recommendation: A sample check should be made of the boxed-in services ductwork to confirm that the construction is adequately fire resisting and that compartmentation behind has not been compromised at services penetrations etc.</p>				
Priority: Man2	Known Quantity: 0	Potential Quantity: 13	Action ID: 114554

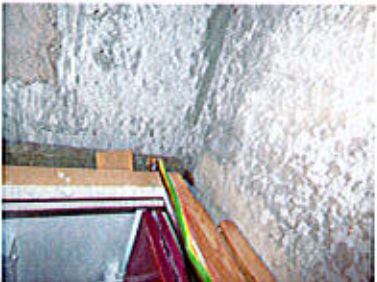
Question - Q.3: Are services risers, shafts, ducts and cupboards in the common area appropriately enclosed with fire resisting construction and adequately fire-stopped?				No
<p>Comment: The services gas riser cupboards sampled did not appear to be adequately fire resisting and/or fire-stopped. The gas intake on the ground floor was not fully fire-stopped from frame to the wall, there were examples where this was sealed correctly on 3rd & 8th floors.</p>				
<p>Recommendation: It is recommended that all gas service riser cupboards are inspected to ensure all are fire stopped to 60 minutes.</p>				
Priority: Man2	Known Quantity: 0	Potential Quantity: 26	Action ID: 114568

<p>Recommendation: The services riser/cupboard construction should be replaced or upgraded to achieve 60 minutes fire resistance.</p>				
Priority: B	Known Quantity: 1	Potential Quantity: N/A	Action ID: 114569

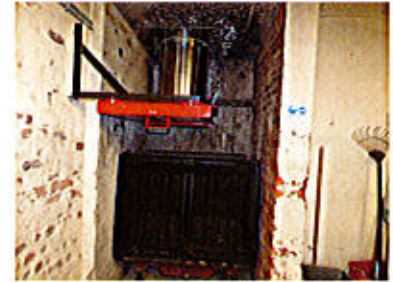
Question - Q.5: If a waste chute is provided within the building are adequate measures in place to limit fire spread/growth? (Consider provision of fusible link dampers and sprinklers etc)				Not Known
<p>Comment: A waste chute is provided in the building, which is located in a permanently ventilated area, separated from the escape route by fire resisting construction of at least 30 minutes. Hopper doors ARE self-closing and HAVE adequate seals. A fusible link damper IS fitted to the base of the waste chute. A sprinkler IS NOT provided at the base of the waste chute. Reported the bin chute hatch is tested daily. No access to the bin chute that runs the height of the building with a vent on the roof.</p>				
<p>Recommendation: Previously Reported - Recommend further investigation is undertaken by a specialist to confirm the condition of the waste chute.</p>				
Priority: Man2	Known Quantity: 0	Potential Quantity: 1	Action ID: 114759

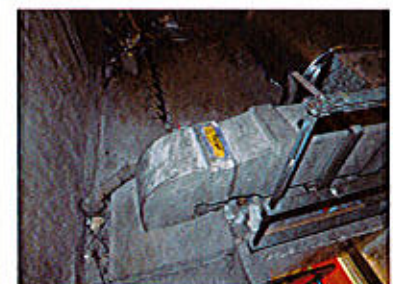
Question - Q.9: If present, are common ventilation systems, ventilation ducts and grills adequate to limit fire spread/growth? (Consider dampers etc.)				Not Known
<p>Comment: It is presumed there is a common ventilation system that runs the height of the building with an extraction system located on the roof. The configuration is unknown.</p>				
<p>Recommendation: Recommend further investigation is undertaken by a specialist to confirm location and condition of the common ventilation system.</p>				
Priority: Man2	Known Quantity: 0	Potential Quantity: 1	Action ID: 114682

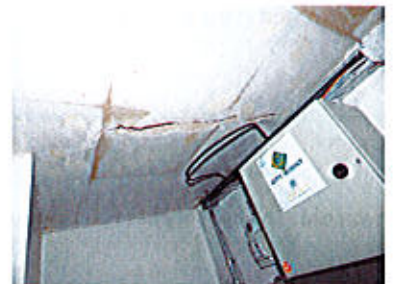
Question - Q.17: Are all other fire spread/compartmentation issues satisfactory? [4]			No
Comment: Other fire spread/compartmentation issues noted at the time of inspection include - There is a breach to the ceiling to the room containing IT equipment in the cleaners store.			
Recommendation: Recommend the breach noted is fire stopped with 60minute fire rated material.			
Priority: B	Known Quantity: 1	Potential Quantity: N/A	Action ID: 114706

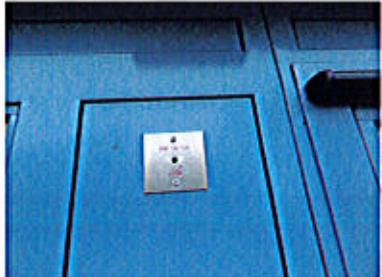
Question - V.9: Are drop key override switch facilities for Fire and Rescue Service access inspected, tested and serviced in accordance with relevant guidance?				Not Known
Comment: No evidence was available on-site to confirm regular inspection, testing and servicing of the system is being carried out.				
Recommendation: Management should confirm/ensure that the drop key override switch facilities for Fire and Rescue Service access are inspected, tested and serviced in accordance with relevant guidance and records kept on-site or in a central database.

Priority: Man2	Known Quantity: N/A	Potential Quantity: N/A	Action ID: 114723
