Fire Risk Assessment

Property assessed: 1-62 Roach Court 42 Hamerton Road Manchester M40 7QP

Client: Northwards Housing

FRA Inspection Date: 14/11/2018
FRA Issued to Client: 30/11/2018
FRA valid to: 30/11/2019
FRA completed by: Savills (UK) Ltd,
33 Margaret Street, London W1G 0JD
T: 020 7409 8737
E: fireriskhousing@savills.com

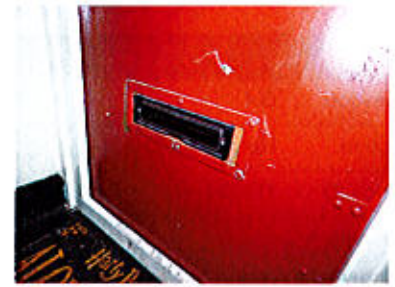
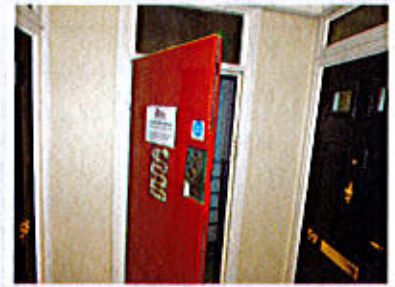
- Known	1		
- Potential	N/A		
Priority	A	Due Date: 31/03/2020	Client Status: Assigned
Question	M.8	Comment: Other common area fire door issues noted at the time of inspection include - Internal doors within the caretaker's store area were not all fire rated doors there is steel door from this area to lift lobby which will provide an unknown level of fire-resistance and the installation would appear to have gaps around the frame.	
Section	Common Area Fire Doors		
Action ID	115251		
Quantity		Recommendation: The common area fire door(s) as noted should be replaced with an FD30S lockable fire door.

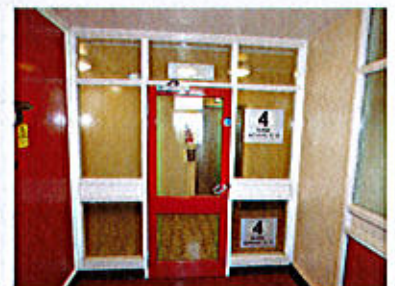
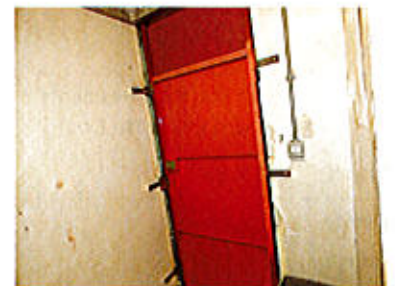
Question	Q.3	Comment: The services riser/cupboards sampled did not appear to be adequately fire resisting and/or fire-stopped. The riser in the ground floor lift lobby was not fully enclosed.	 
Section	Limiting Fire Spread		
Action ID	115278		
Quantity		Recommendation: The services riser/cupboard construction should be replaced or upgraded to achieve 60 minutes fire resistance.

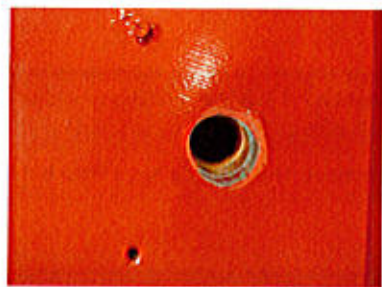
Action ID: 115290

Question - Q.16: Are all other fire spread/compartmentation issues satisfactory? [3]			No
Comment: Other fire spread/compartmentation issues noted at the time of inspection include - There are 2 service riser cupboards with holes in the doors on 9th & 10th floors.			
Recommendation: The holes noted should be sealed up with fire resisting construction or FD30s door replaced - period of fire resistance required is 30-minutes.

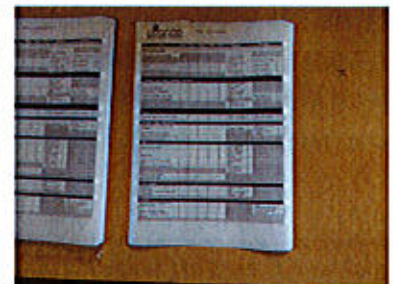
Comment: From information received on-site, it would appear that routine in-house fire safety checks are not being carried out at present as there has been a change of staff and the daily checks are not being implemented OR not recorded only blank forms could be located.

Recommendation: Management should confirm/ensure that routine in-house fire safety checks are carried out on a regular basis (daily or weekly depending on building usage) and records kept on-site or in a central database.

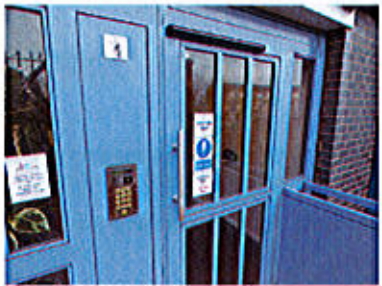
Comment: No evidence was available on-site to confirm regular inspection, testing and servicing of the system is being carried out.	
Recommendation: Management should confirm/ensure that the drop key override switch facilities for Fire and Rescue Service access are inspected, tested and serviced in accordance with relevant guidance and records kept on-site or in a central database.
